WETLAND RESTORATION TECHNICAL GUIDE USING INNOVATIVE SOD STRUCTURES

SANTA FE, NEW MEXICO
2023

Vrooman, S., and Vrooman, J., 2023. Wetland Restoration Technical Guide Using Innovative Sod Structures. New Mexico Environment Department, Surface Water Quality Bureau, Santa Fe, New Mexico.

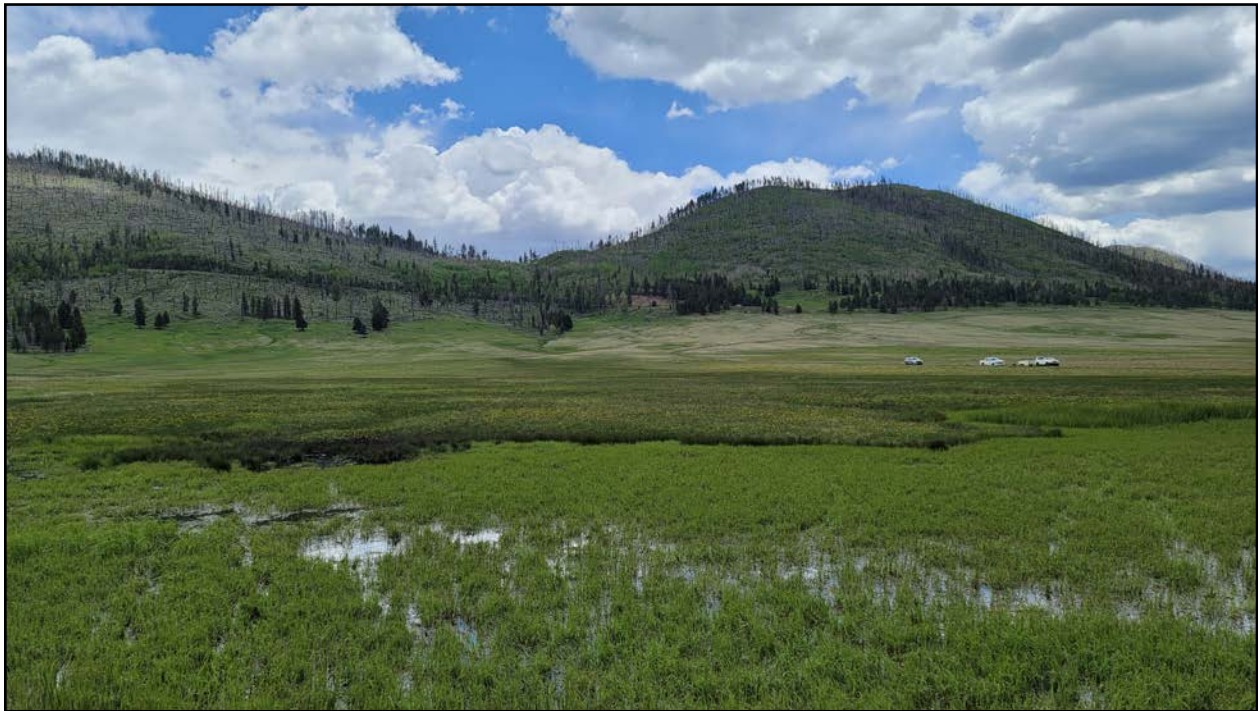
Sheet Flow returned to the Headwaters of the East Fork of the Jemez River Watershed.

However, restoring the natural hydrology of the site can have a hugely positive impact on vegetation, water storage, and the overall watershed. Spreading snowmelt out of gullies back on to natural landforms as sheet flow can quickly allow soil infiltration and saturation and native wetland plants to re-establish. Restoration projects working in these upper watersheds, such as the East Fork Headwaters, constructed over 200 structures over 400 acres. Many of these treatments were very small, but installed in the most effective locations to restore the original hydrology of the landscape.

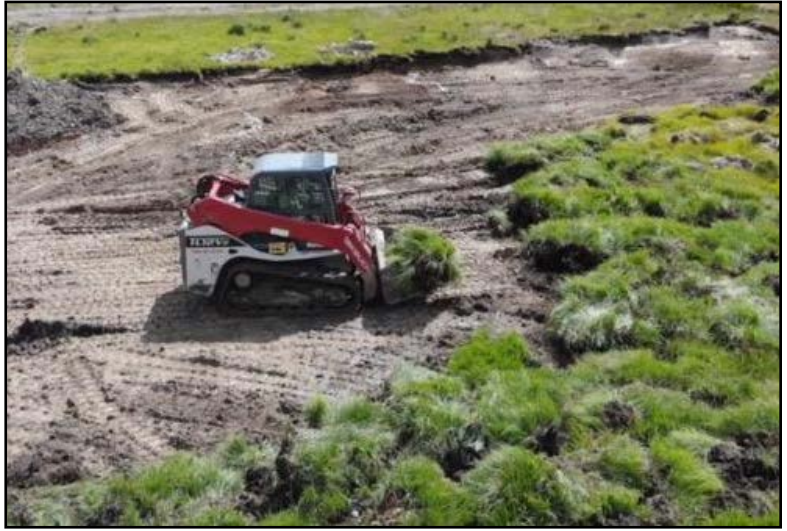
Sod tile being removed with rubber-tracked loader and added to sod tiles harvested before restoration structure is built. The wetland sod that is removed and replaced is placed in a "runway," so that the water that flows out of the structure irrigates this area and helps with re-vegetation and compaction of the soil. See further description on p. 26.

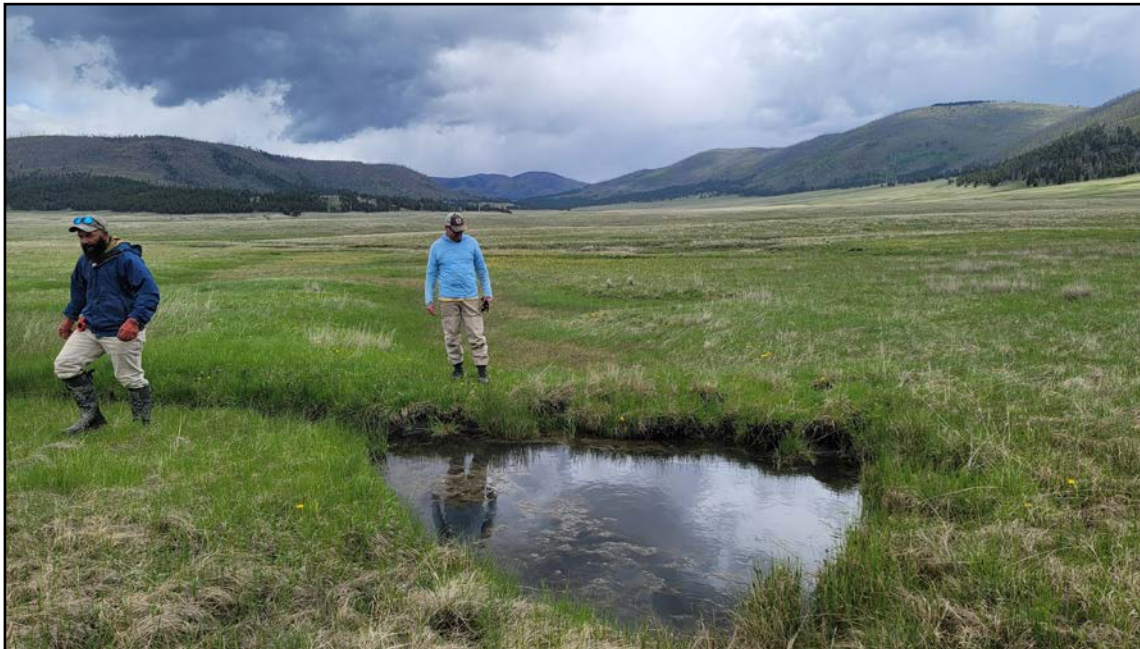
EXCAVATOR PLUG

A much smaller version of the plug and pond (see next Technique) is the excavator plug. This small plug is constructed using only an excavator, and is used in gullies less than 2 feet deep and 5 feet across. The excavator plug can be constructed in less than 1 hour and many of them built in the course of a day. More time can be spent tracking the excavator to each site than in actual construction.

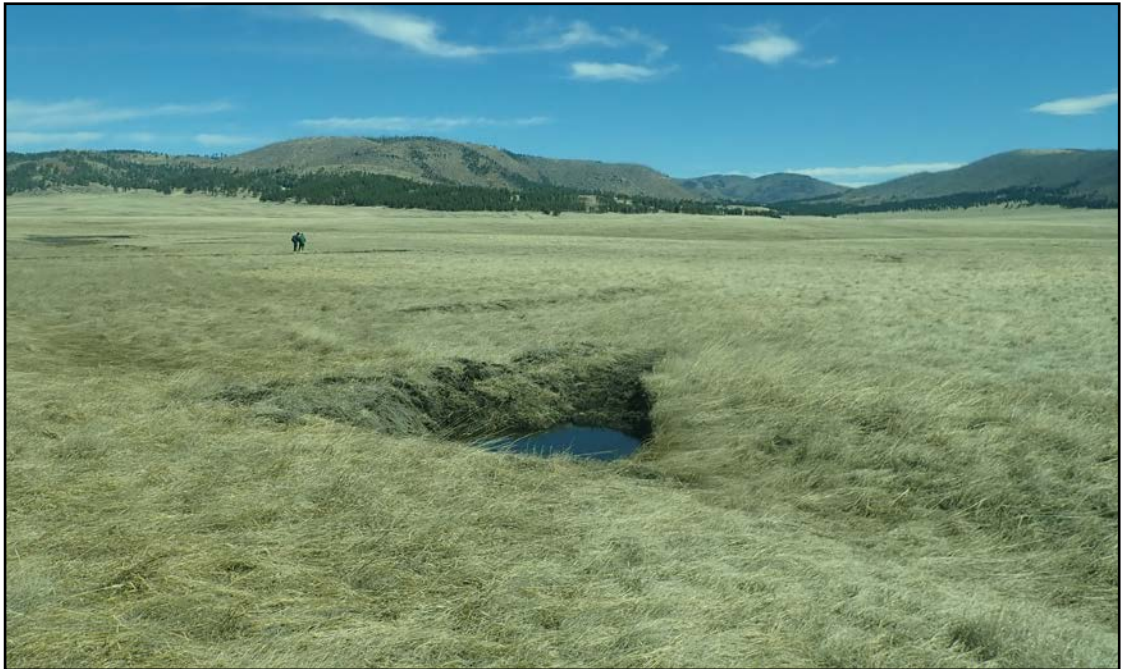
[Above] Excavator Plug structure in early spring after snowmelt. The water is flowing toward the person downslope.

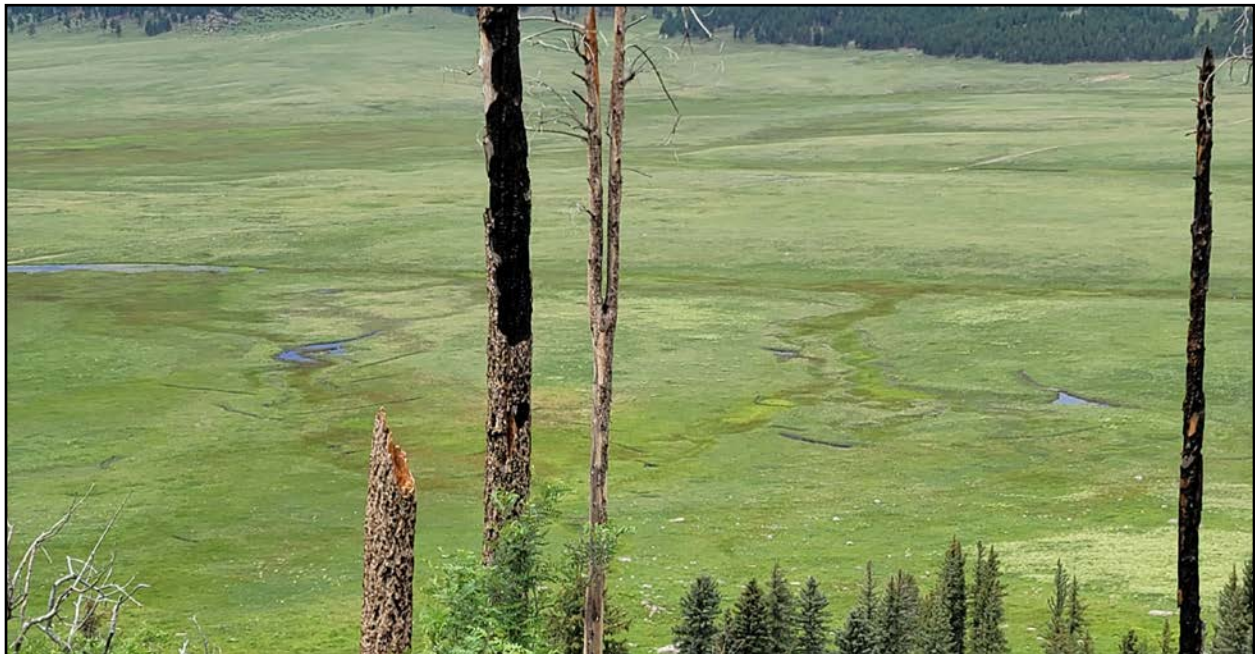
Plug and Ponds returning hydrology to slope wetlands in the East Fork Headwaters.

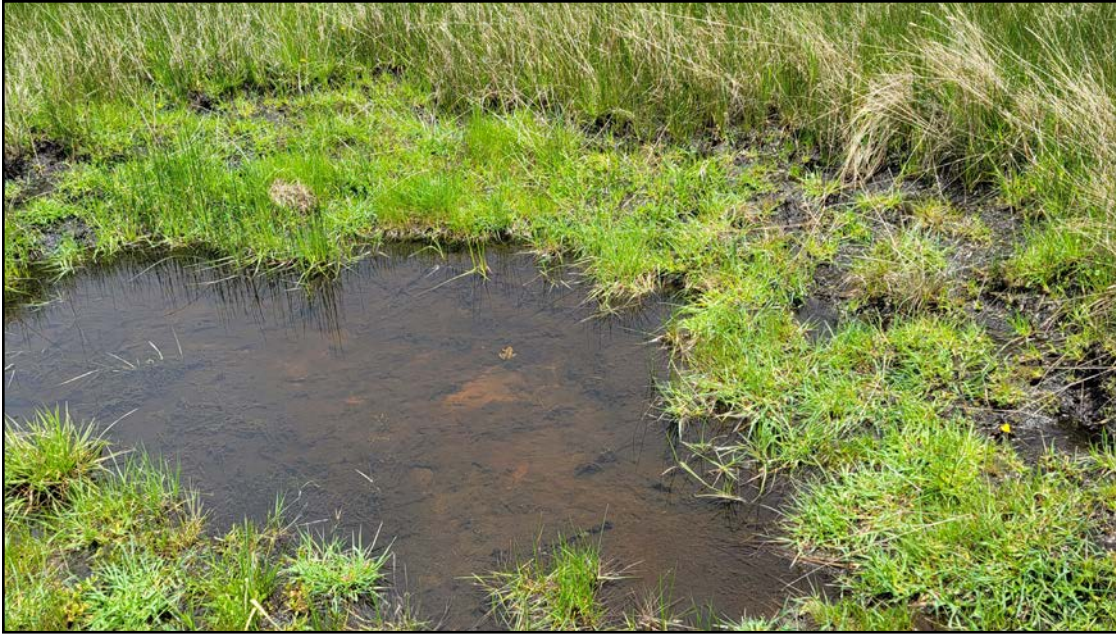
[Above] A portion of a constructed sod bowl. A Northern Leopard Frog is the small tan object in the center of pond.

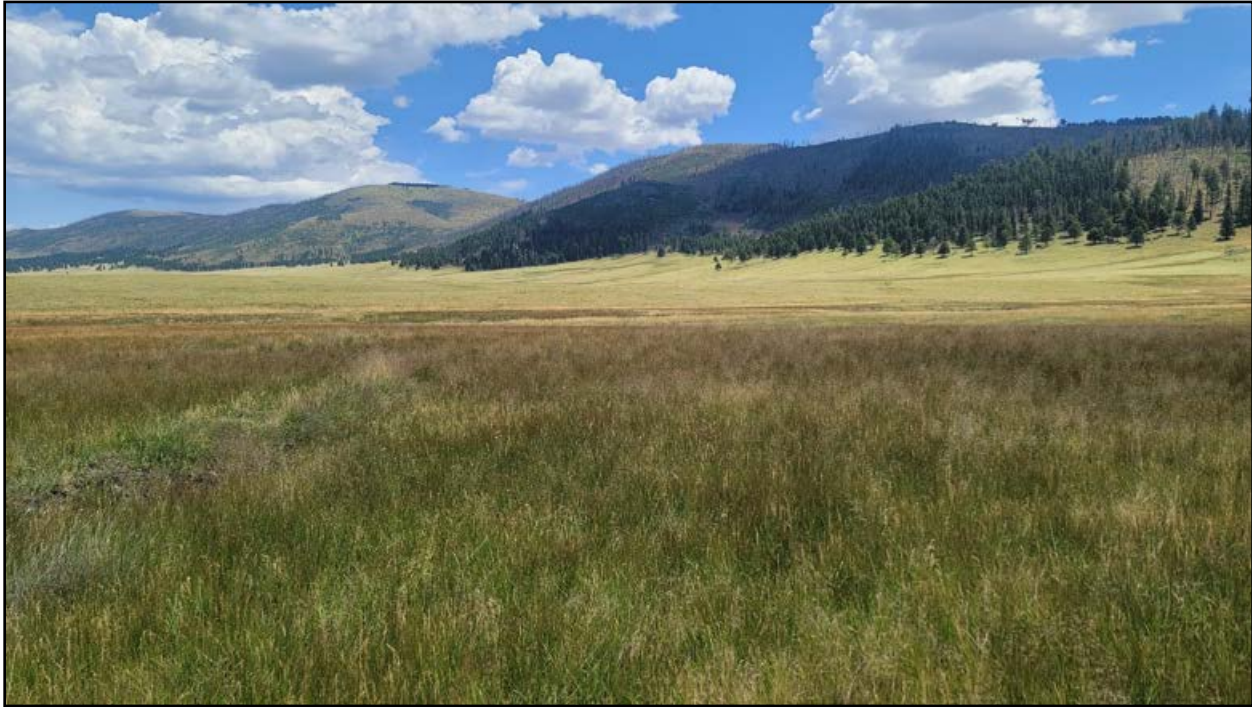
Lighter green vegetation is a mix of Carex utriculata/Carex praegracilis. Darker green vegetation is Juncus balticus responding to increased wetness.

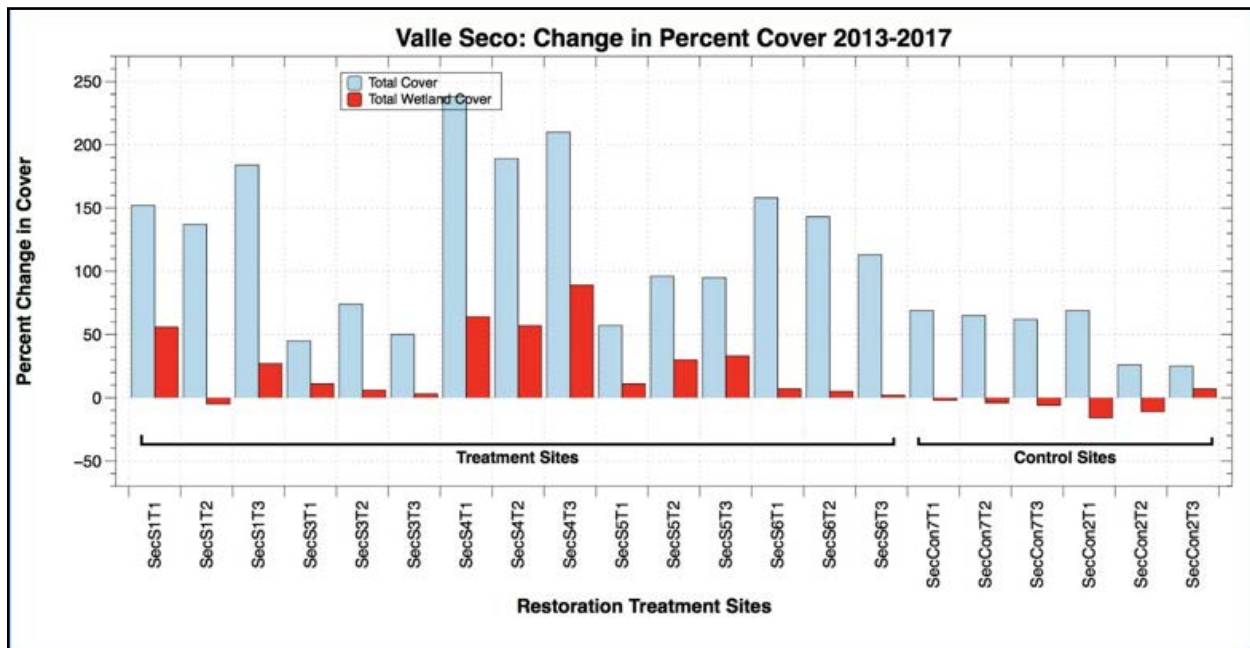
Figure 6. Comparison of vegetation changes in percent cover and wetland species cover along Valle Seco treatment and control transects.

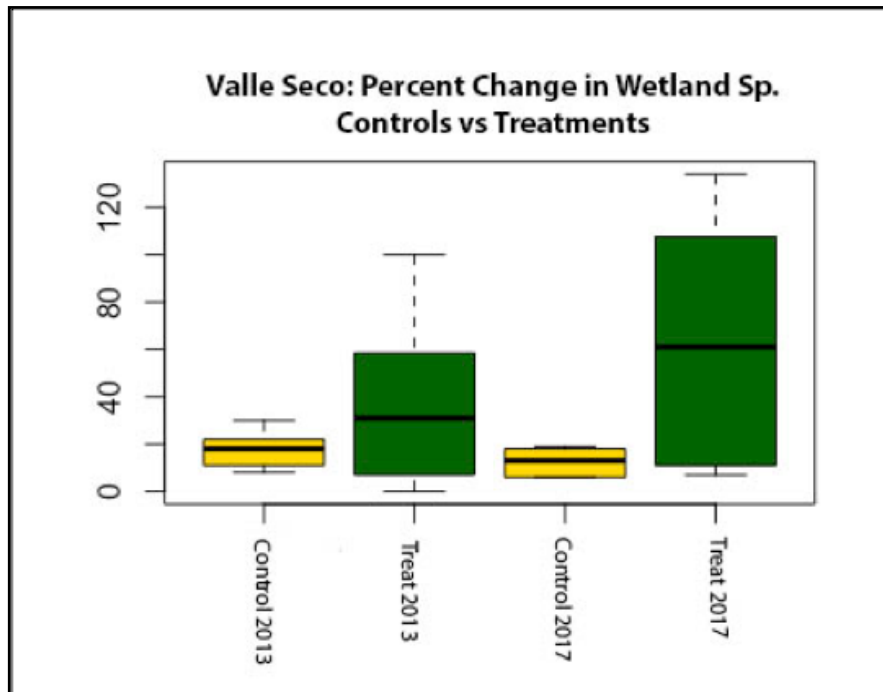
Figure 7. Comparison of change in wetland species along Valle Seco control versus treatment transects.

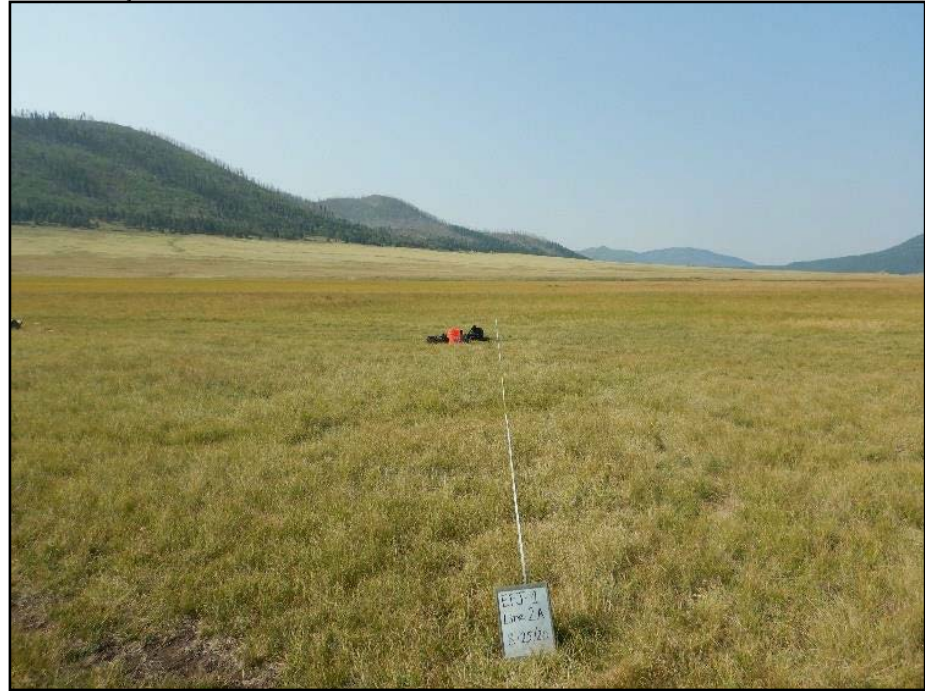
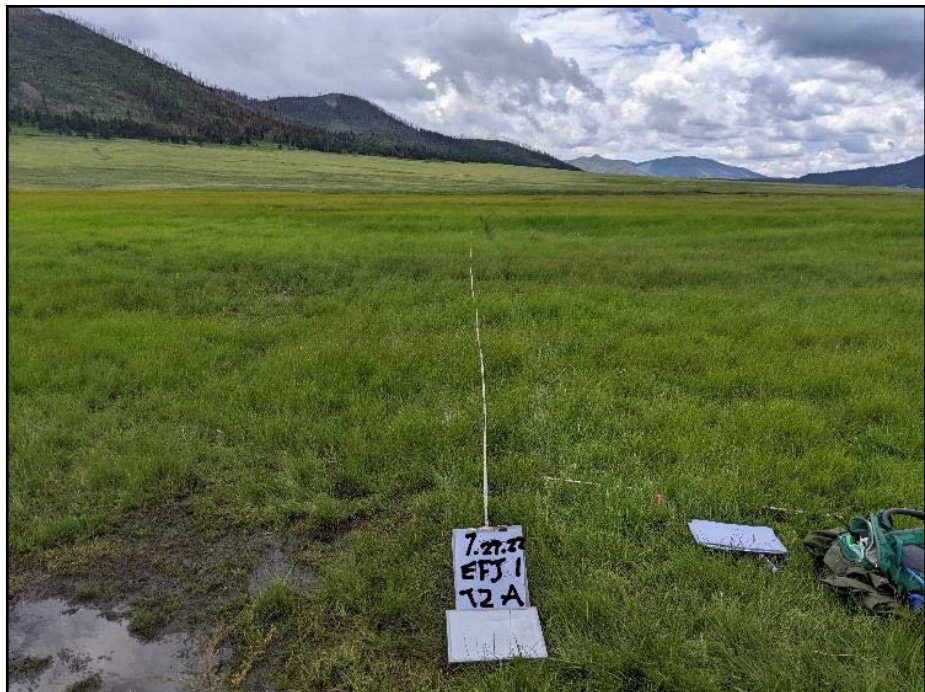
Examples of the photos taken by the Valles Caldera Vegetation survey crew during their transect monitoring. The top is 2020 and the bottom is the same spot in 2022.

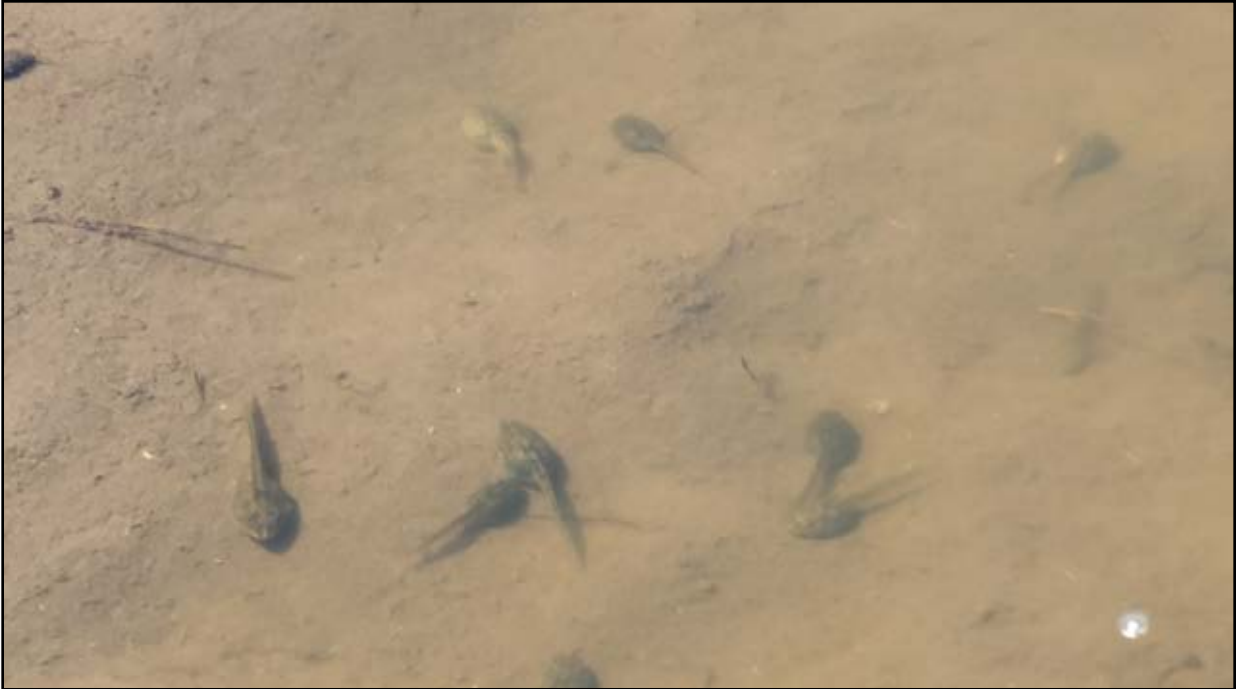
Northern Leopard Frog Tadpoles in Excavator Plug.

filling with water. Small excavator plug ponds off of the main channel with water were found to be full of tadpoles, and provide a refuge from trout predation.
